# Safety Alert

## Counterweight Rigging Incident

April 26, 2018

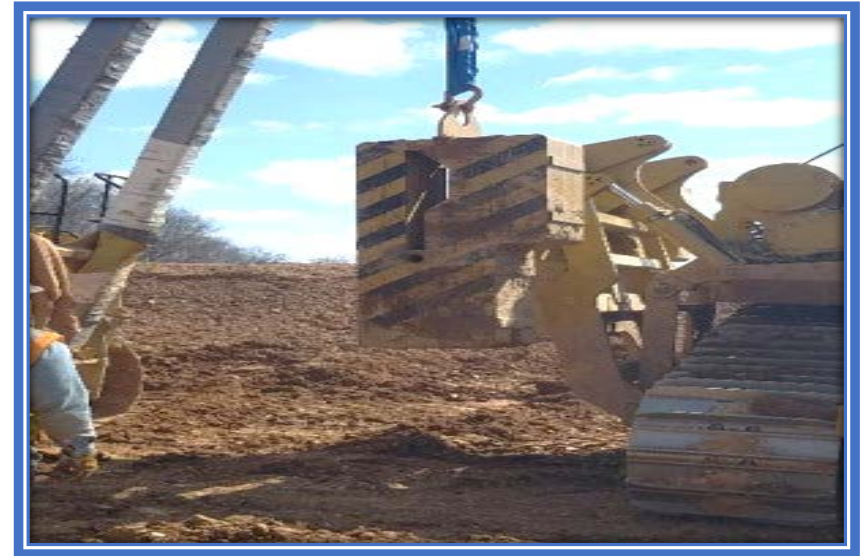
- The counterweight lift was rigged by the contractor crew. A lifting strap was used in a basket configuration, with a lifting capacity of 12,800 lb.
- The lifting strap (synthetic web sling) was attached to the counterweight with a shackle.
- Following the incident, the lifting strap was found in two pieces.
- The injured contractor was in the line-of-fire when the load fell.
- A safety latch was not used by the contracting crew on the hook of the side boom performing the lift.

- Conduct thorough inspections on rigging equipment before use and maintain lifting straps at all times. Out of service or damaged rigging should be tagged and destroyed.
- Ensure rigging configuration protects straps from sharp or abrasive edges.
- Use tag lines or push poles if there is a need to position a suspended load. Avoid being in the line-of-fire.
- Use of safety latches on lifting hooks are required for overhead lifting and rigging operations, except when using a side boom to lower pipe into an excavation.
